**Flood Control Project Maintenance  
Levee Inspections****LMA District Cover Sheet****Spring 2015 Levee Inspection Results****Sutter Maintenance Yard Maintenance Area 0017**

Waterway			Bank	Unit Miles
Unit No. 01 Lake County Sutter Maintenance Yard - Middle Creek			Left	3.87
	Spring (March - May)	Summer (June - August)	(September - November) Fall	Winter (December - February)
Unit Maintenance Rating (Fall Only)				
Date of Inspection	03/12/2015 - 03/12/2015			
DWR Inspector	Bob Duffey			
Accompanied By	Bryan Reniff Sutter Maintenance Yard

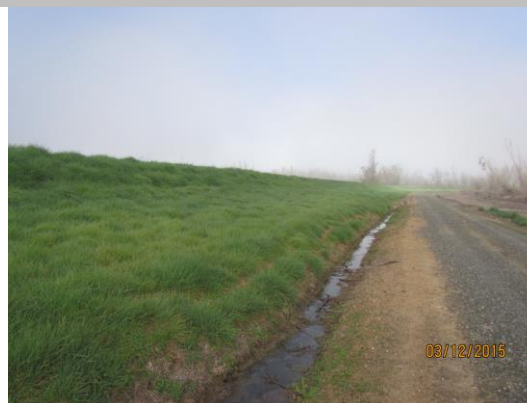
Photo 1 of 1 : SP\_2015\_MA0017\_339\_1\_20150406\_00100.jpg

LM Start	4.09	Rating **	A	Issue No.	1
LM End	7.23	Issue Type +	Ma	Location *	LS
Category	Earthen Levee			GPS Latitude/Longitude	
				Start	End
Item	Vegetation			39.142155 °	39.118675 °
				-122.902343 °	-122.884772 °
DWR ID	DWR_MA0017_01_s _ 2015_1				
Action/Comments					
Remove the wild growth other than native grasses from the levee slopes.

View of the native grasses along the landside slope.

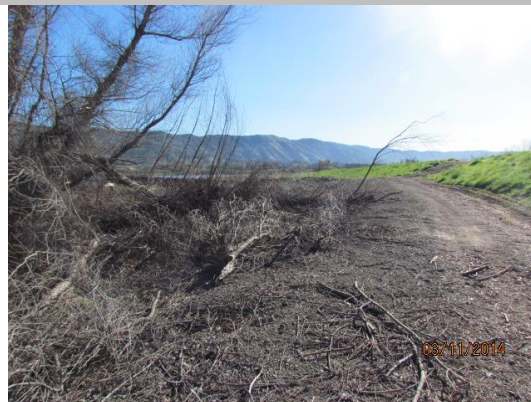
Photo 1 of 2 : SP\_2015\_MA0017\_339\_18\_20150310\_00004.jpg

LM Start	5.27	Rating **	M	Issue No.	18
LM End	5.27	Issue Type +	En	Location *	LS
Category	Earthen Levee			GPS Latitude/Longitude	
				Start	End
Item	Encroachments			39.127544 °	39.127544 °
				-122.893763 °	-122.893763 °
DWR ID	DWR_MA0017_01_s_2014_18				
Action/Comments					
Tree or limb

View of the downed tree along the landside toe.

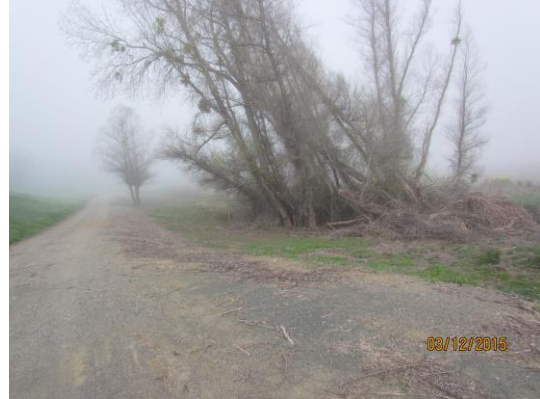
Photo 2 of 2 : SP\_2015\_MA0017\_339\_18\_20150406\_00099.jpg

LM Start	5.27	Rating **	M	Issue No.	18 (cont)
LM End	5.27	Issue Type +	En	Location *	LS
Category	Earthen Levee			GPS Latitude/Longitude	
				Start	End
Item	Encroachments			39.127544 °	39.127544 °
				-122.893763 °	-122.893763 °
DWR ID	DWR_MA0017_01_s_2014_18				
Action/Comments					
Tree or limb

Sutter Yard remove the tree from the landside toe.
